Algae Bloom Seen in SML

In early 2019, several residents of Smith Mountain Lake reported an increase in the amount of algae or “green stuff” they are seeing in the lake and especially along the shoreline. The Smith Mountain Lake Association (SMLA) took quick action to investigate these sightings, and several samples were collected and analyzed.

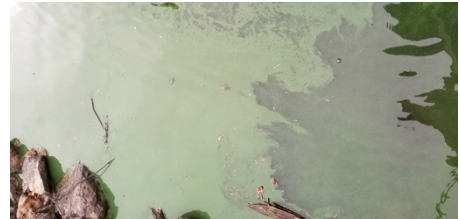
- a) Green algae – The SMLA Water Quality Monitoring Program in 2018 reported the presence of green algae increased over the 2017 report; water appears to have a green hue. 56% percent of the algae found in SML in 2018 were green algae. Green algae are harmless and tend to dissipate after 24 – 48 hours. However, occurrences tend to increase with more frequent and heavier rainfall, which we have experienced throughout 2018 and into this year, providing increased nutrients within the runoff into the lake.

Everyone that lives on or near the lake should consider taking steps to reduce nutrient runoff and sediment erosion from your properties, such as installing a buffer landscape above your riprap.

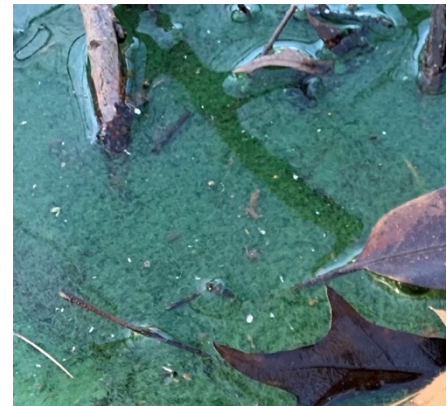
- b) Blue-Green algae – One specific sample analyzed contained blue-green algae. Only 18% of algae found in SML in 2018 were of the Blue-Green variety that we would like to minimize in the lake because Blue-Green algae block sunlight from entering the water and have the potential of producing toxins after it dies. An example of blue-green algae may be seen on the right.
